ST. JOSEPH PENINSULA, GULF COUNTY, FLORIDA
Beach Re-Nourishment
and
Environmental Enhancement Project
RECOMMENDATIONS

January 23, 2018

mrd *mrd associates, inc.*
Coastal Engineering

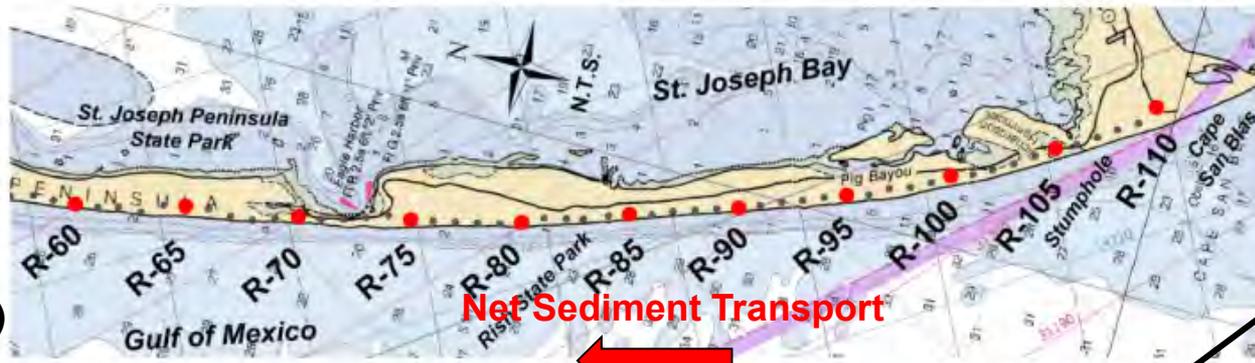
SHORELINE AND VOLUME CHANGES

North Limits (V-74.8 to R-85) are gaining sand.

South Limits (R-90 to R-105.5) are eroding.

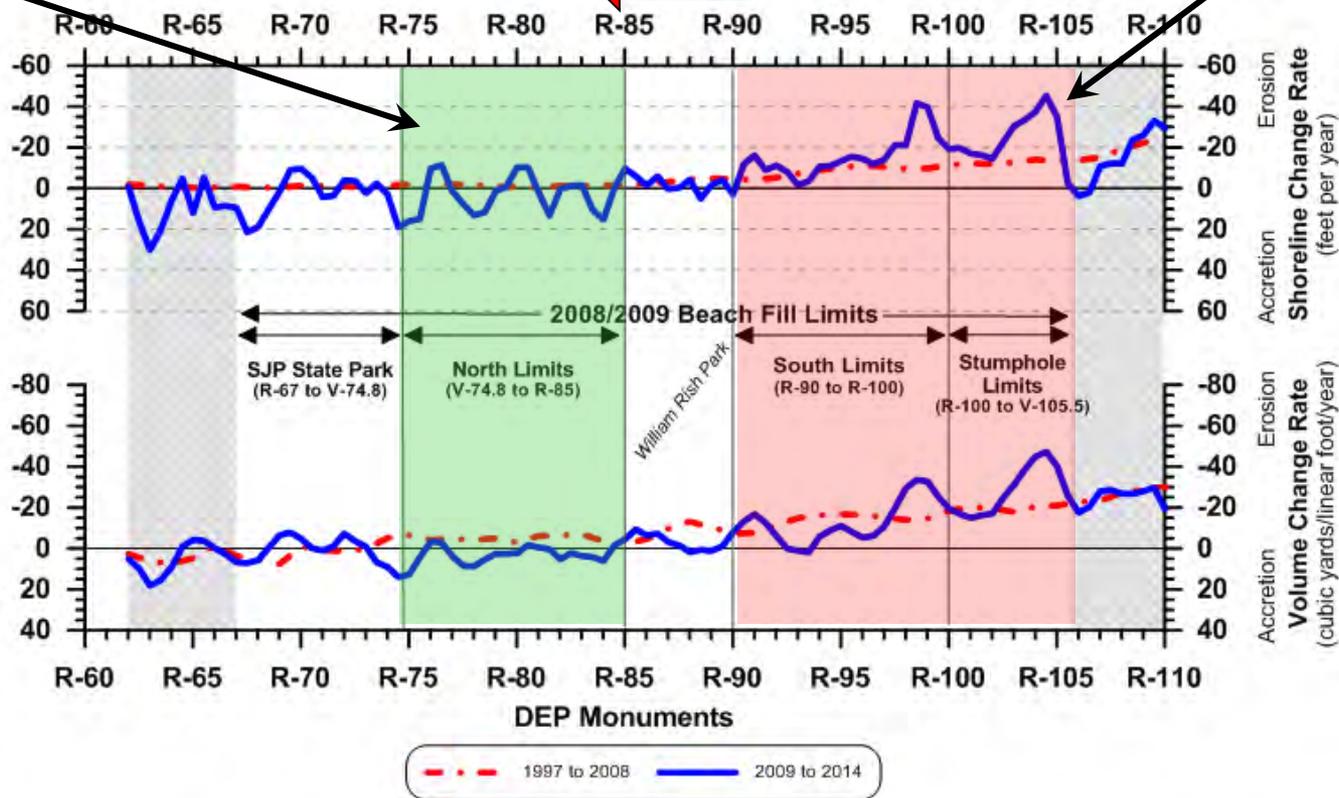
VOLUME CHANGES AND PROPOSED BEACH FILL

**South Limits lost sand
between 2009 and 2014.**

**This is consistent with →
pre-beach project trends.**

**North Limits gained sand
between 2009 and 2014.
This is consistent with
pre-beach project trends.**

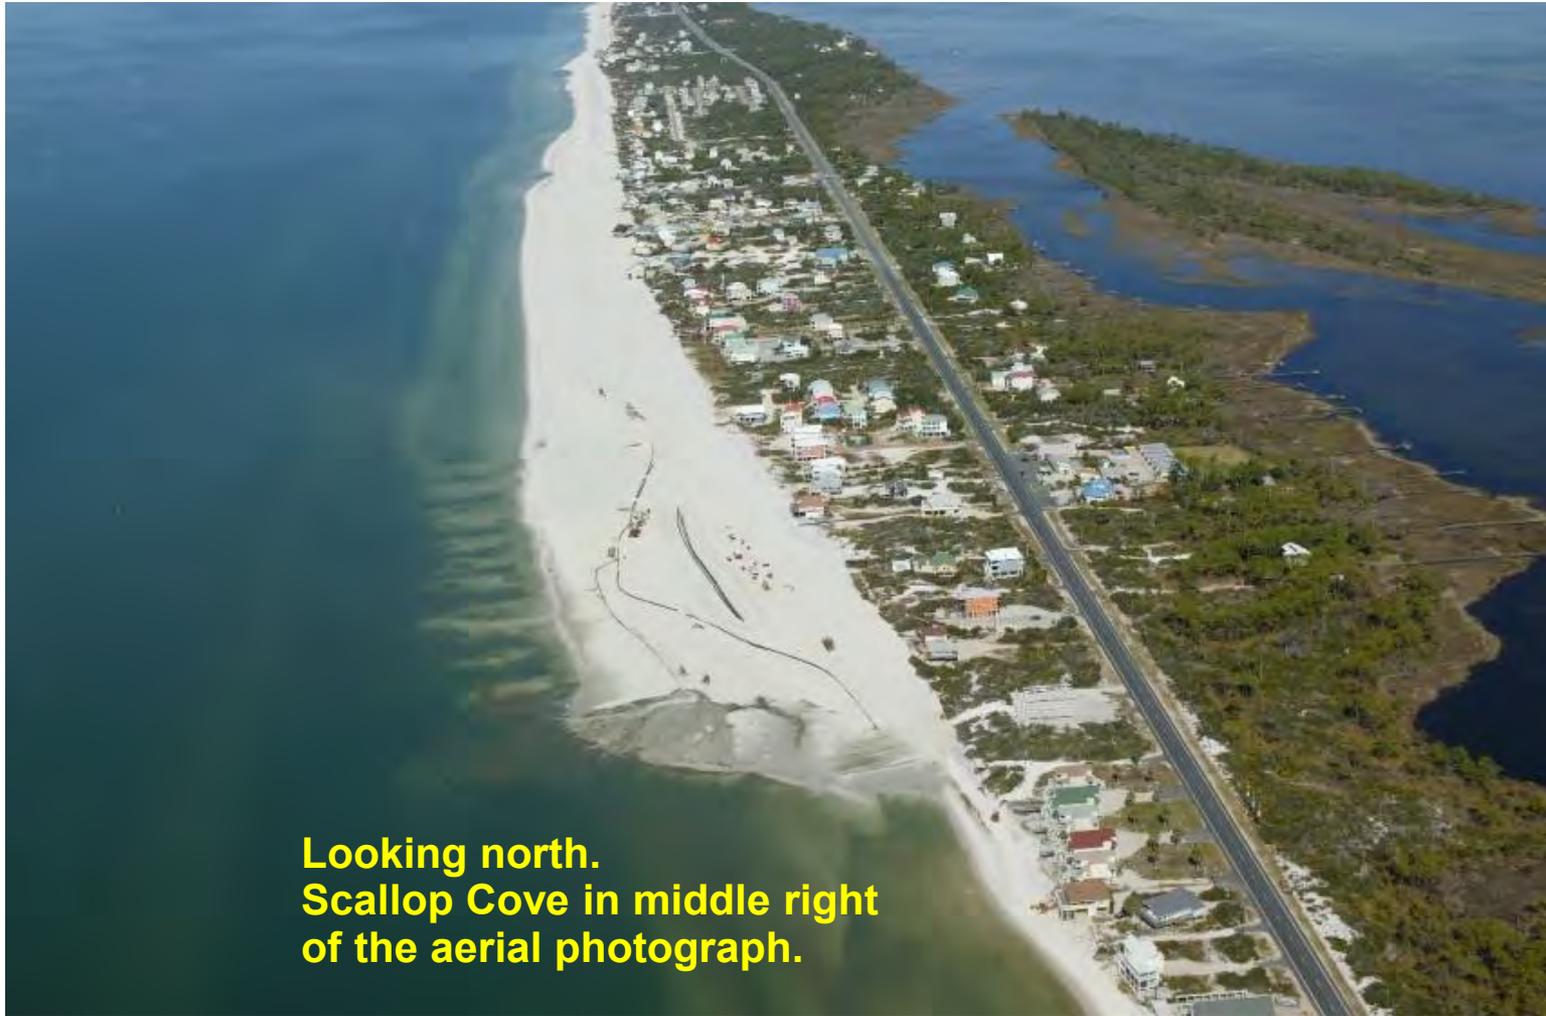
CONSTRUCTION (10/08)

Looking north.
Scallop Cove in middle right
of the aerial photograph.

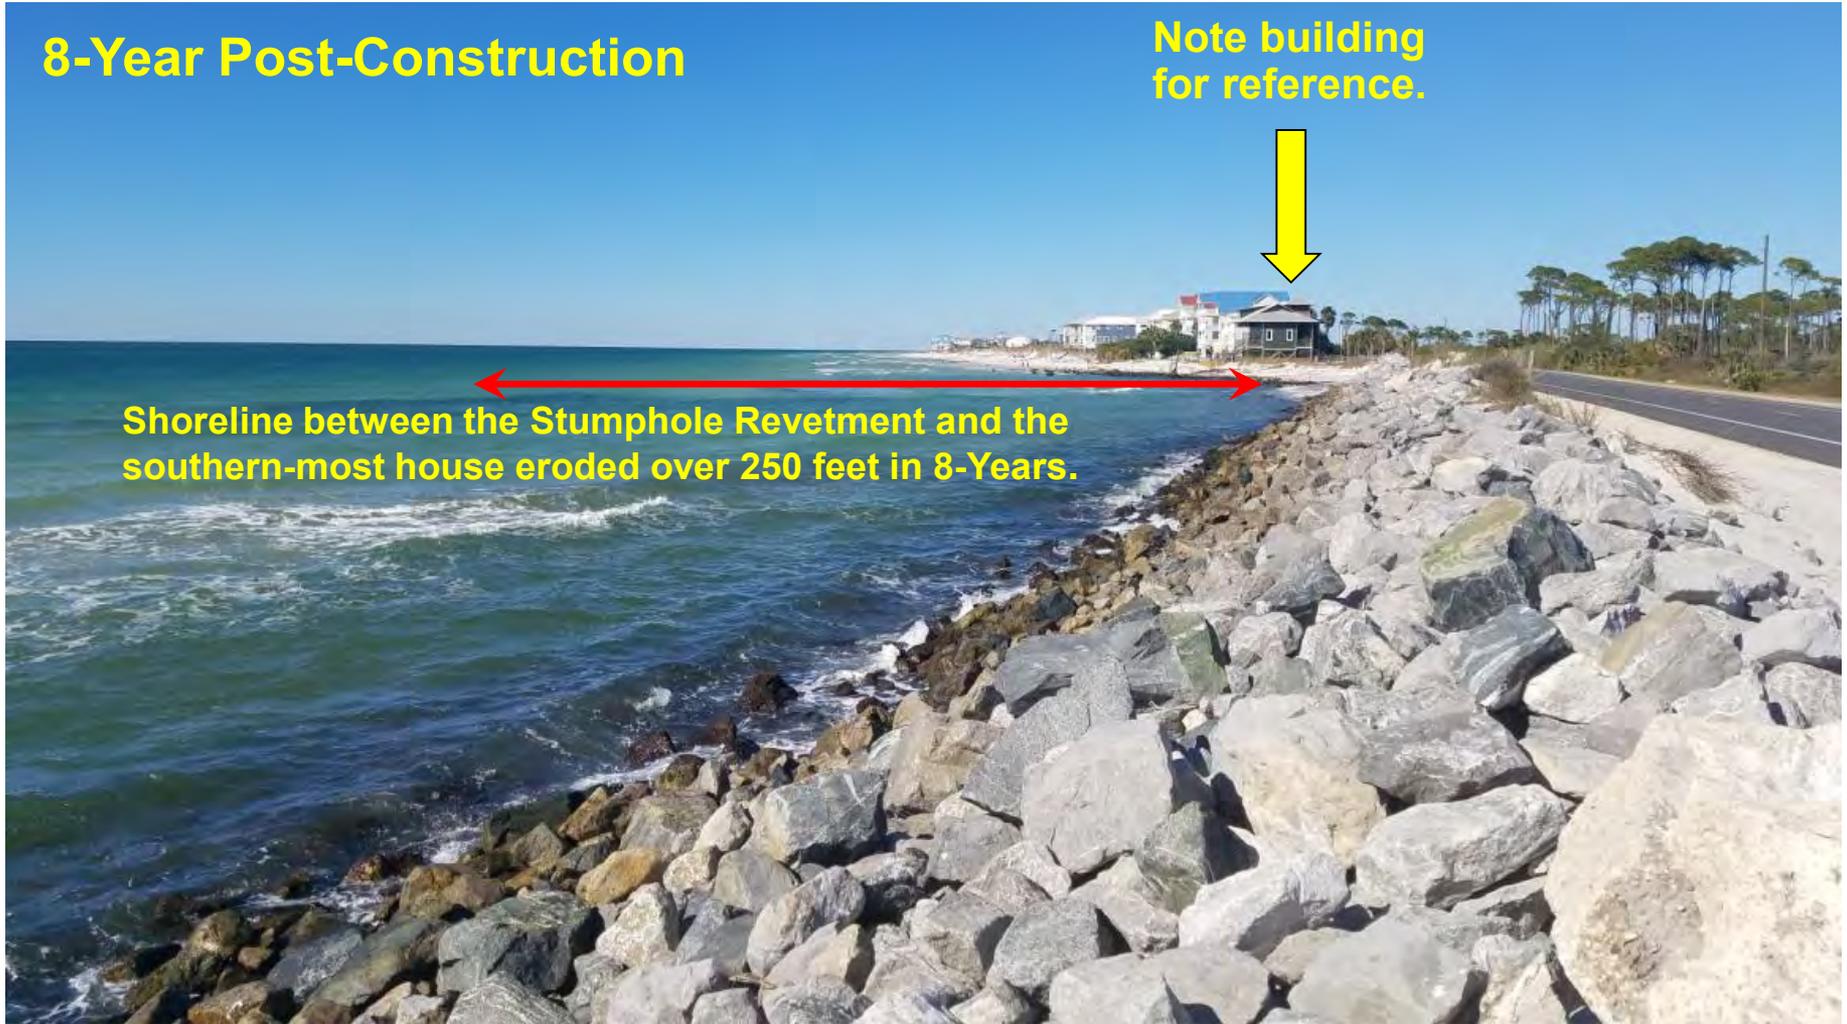
NORTH OF STUMPHOLE (12/5/17)

Shoreline between the Stumphole Revetment and the southern-most house eroded over 250 feet in 8-Years.

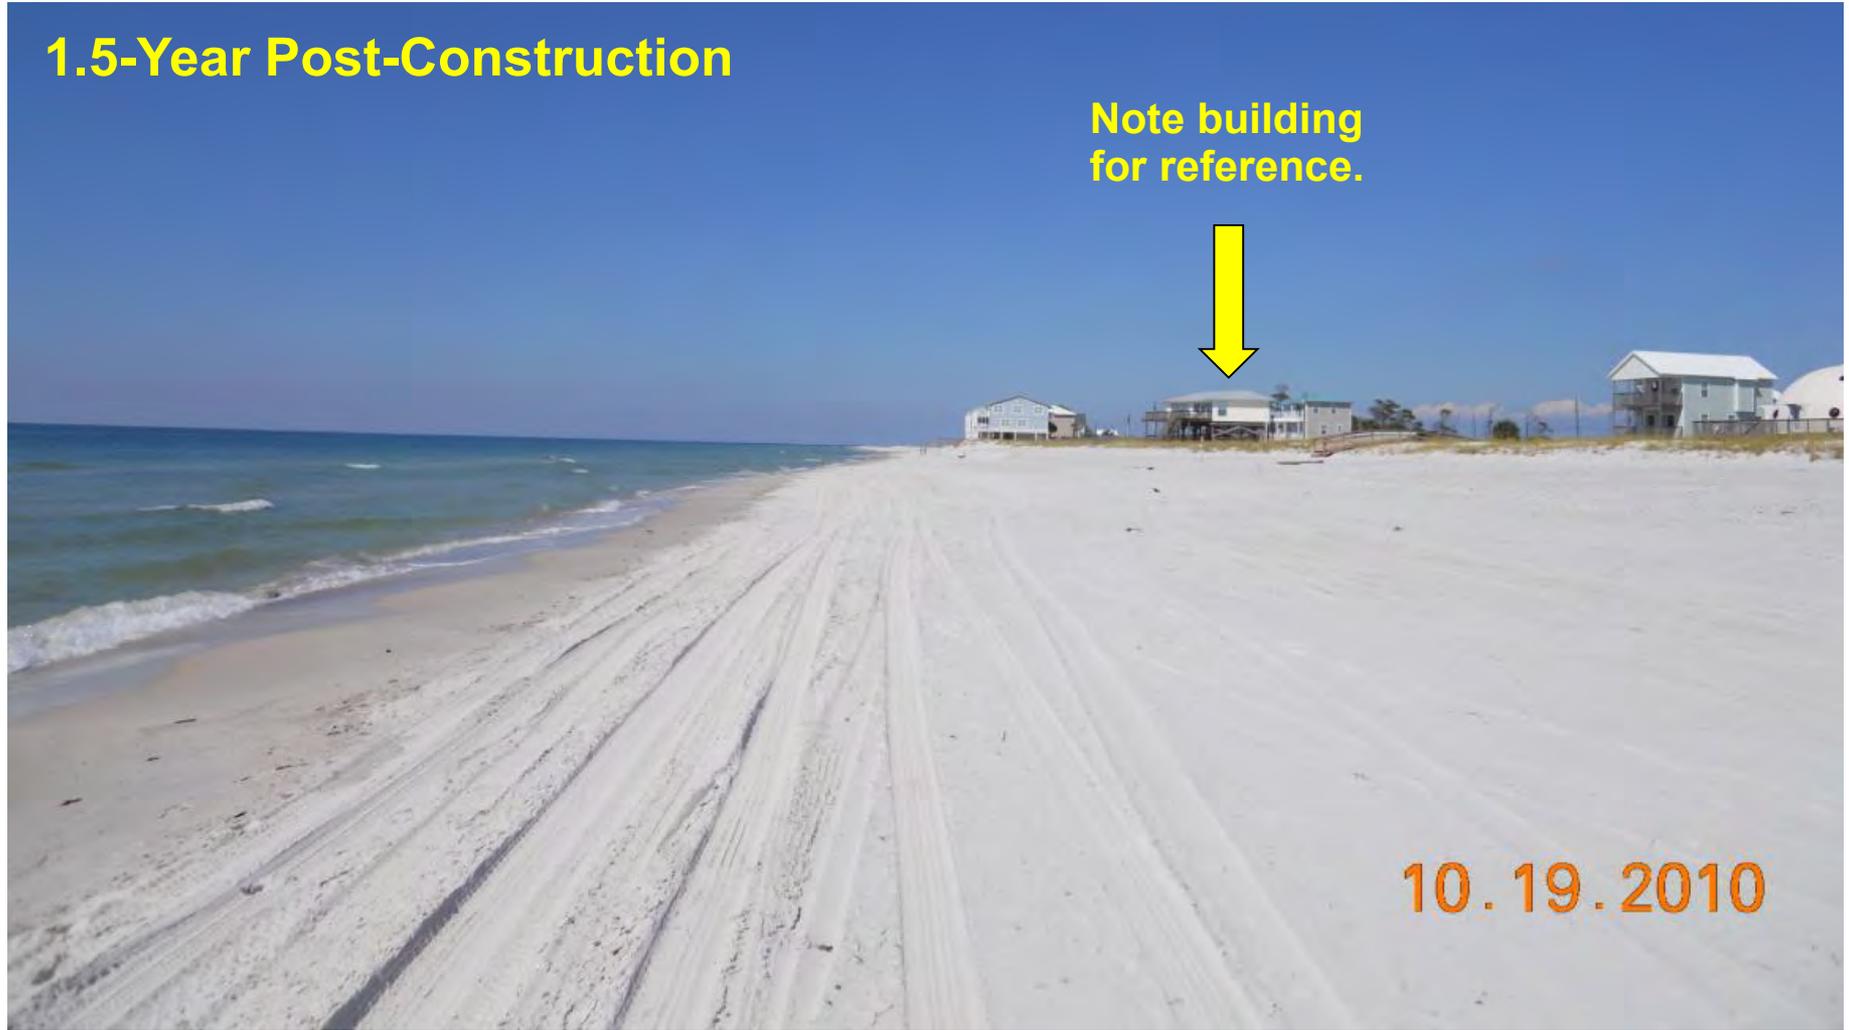
NORTH TOWARD SUNRISE/SUNSET (10/19/10)

Note building
for reference.

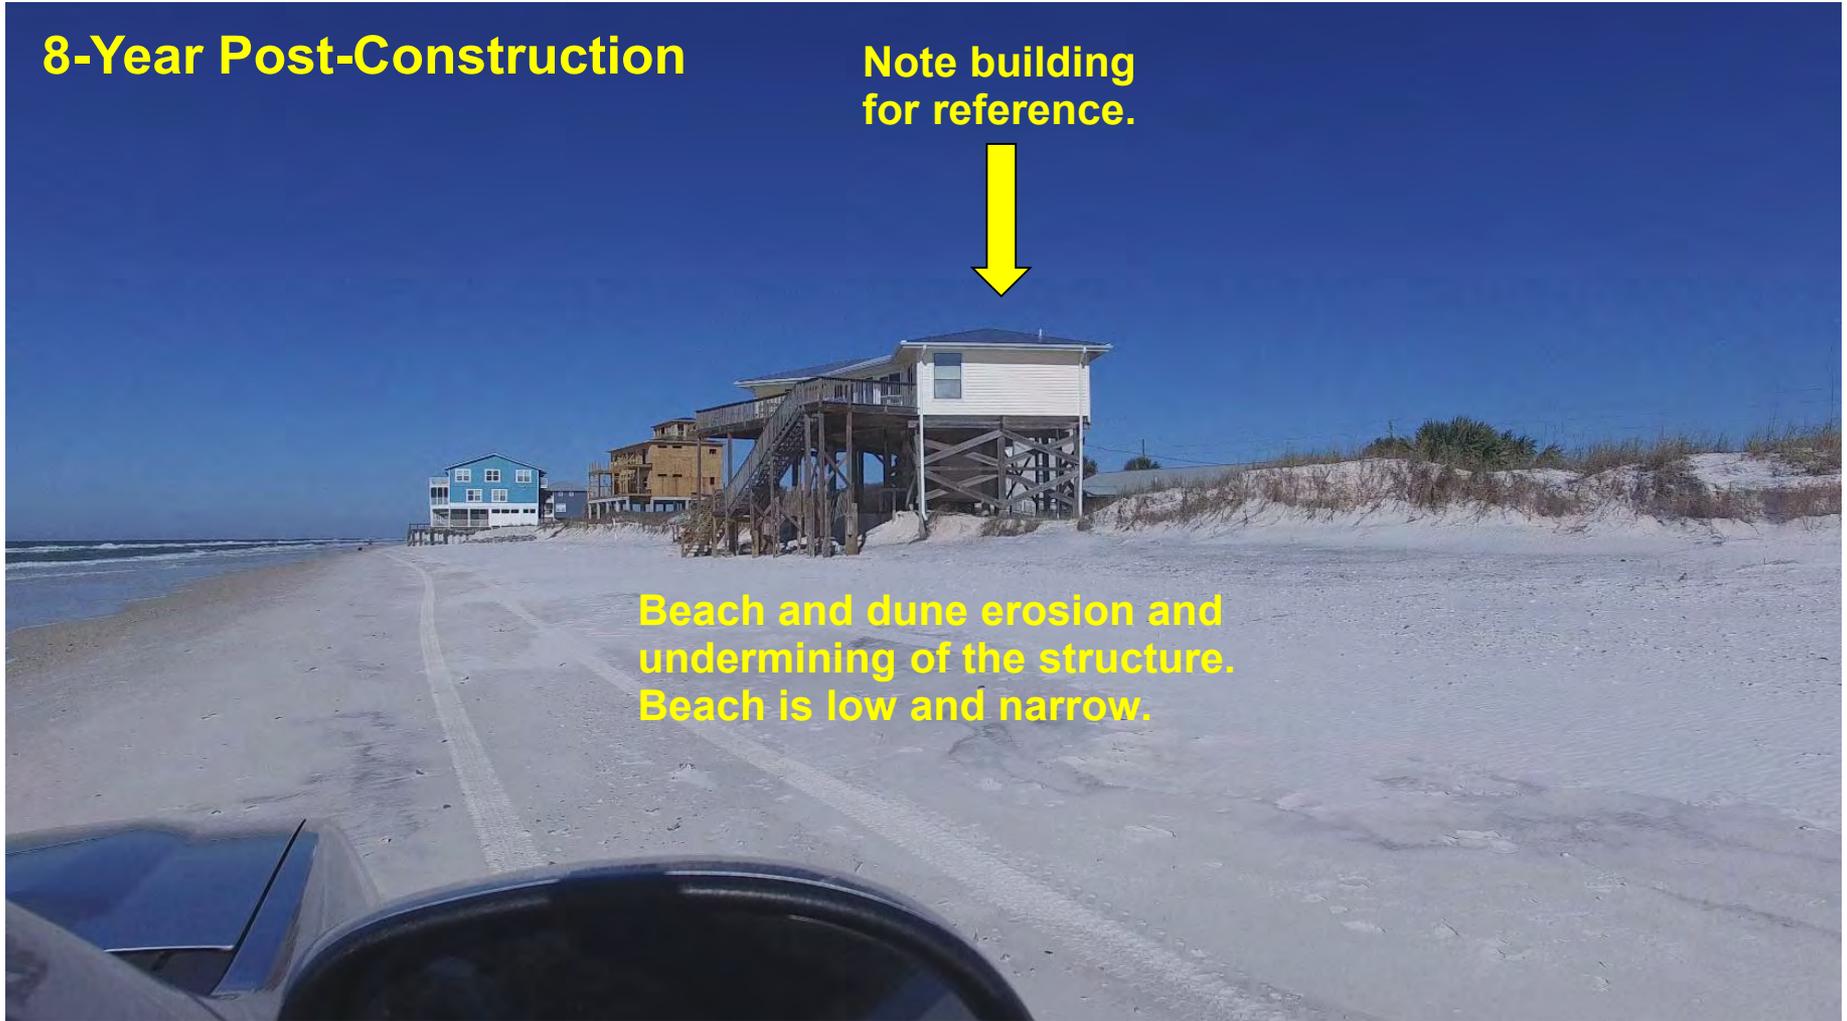
NORTH TOWARD SUNRISE/SUNSET (1/4/18)

**Beach and dune erosion and
undermining of the structure.
Beach is low and narrow.**

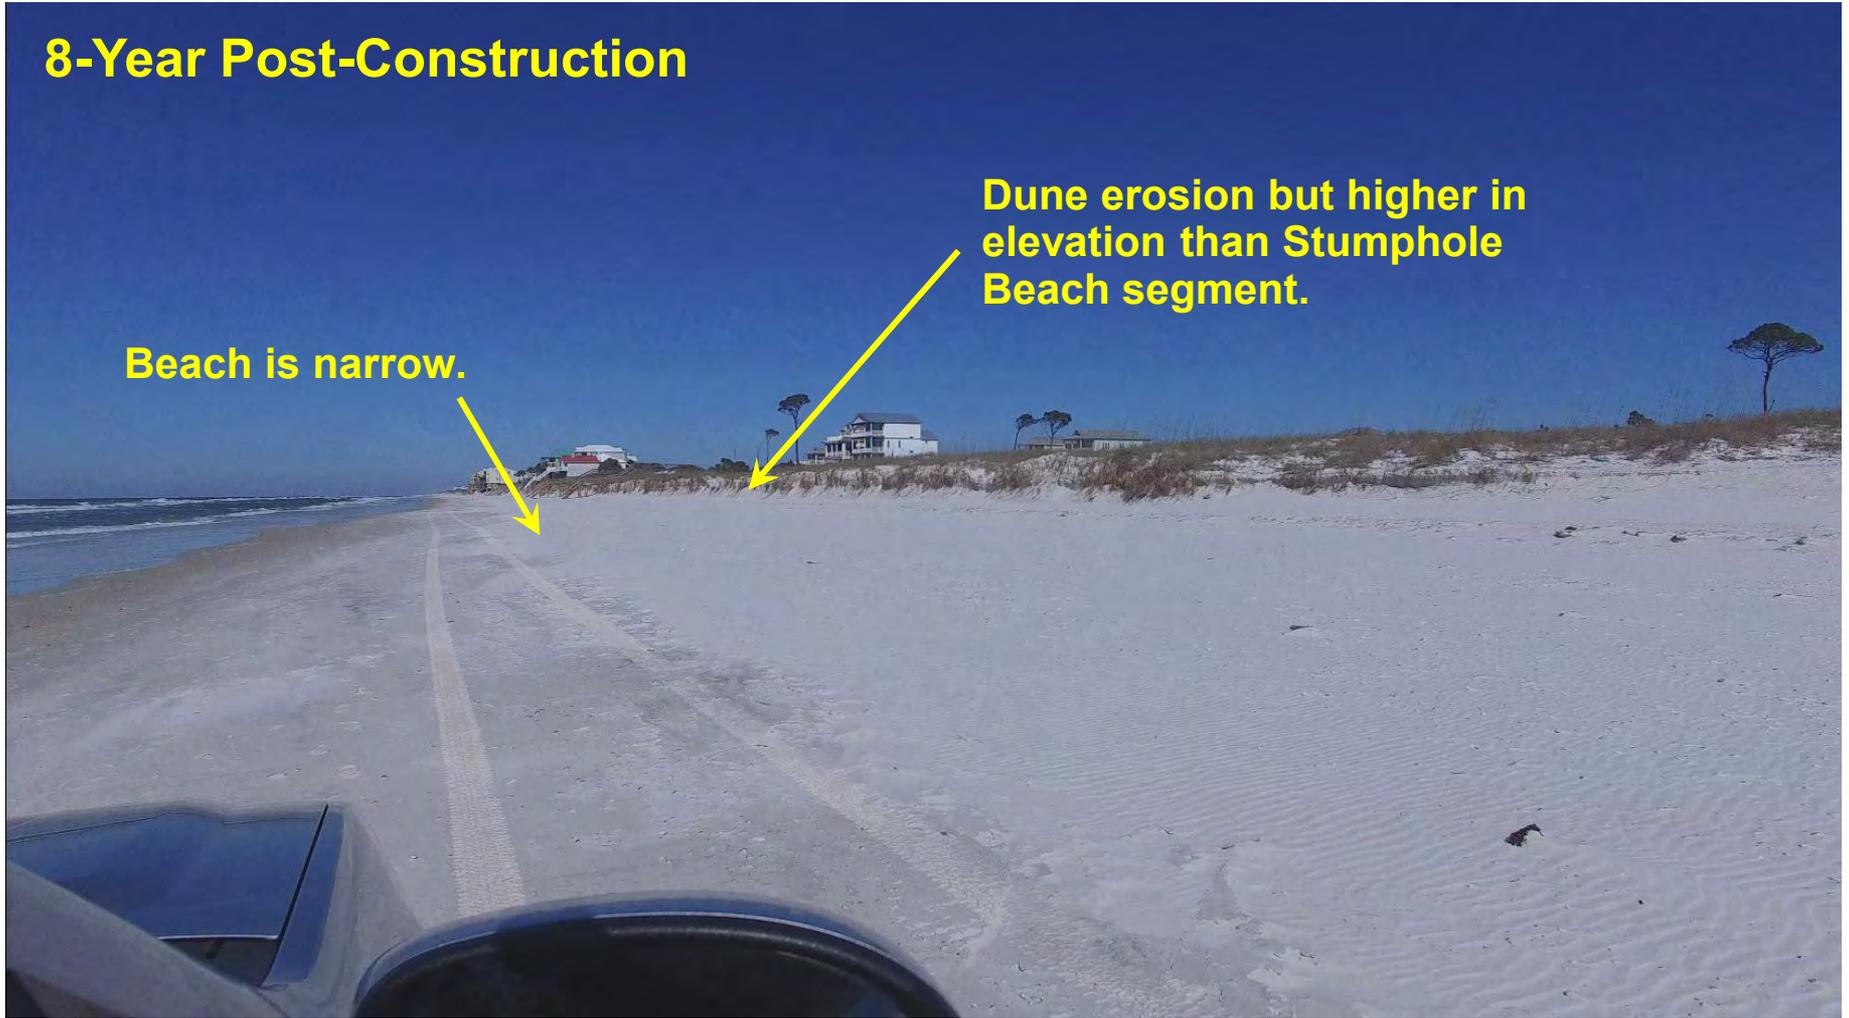
SEAGRASS (1/4/18)

Beach is narrow.

Dune erosion but higher in elevation than Stumphole Beach segment.

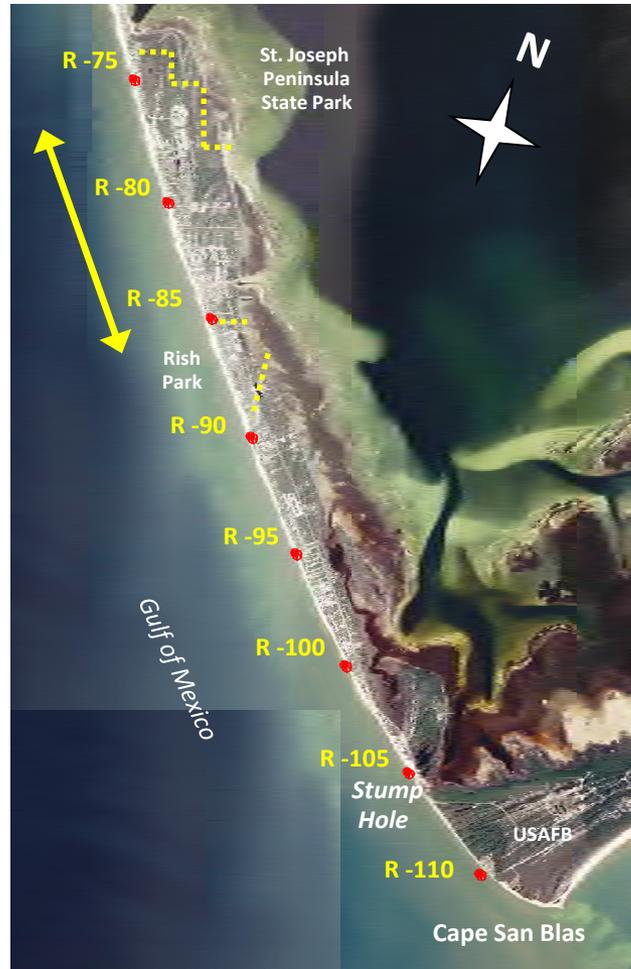
EXISTING CONDITIONS – NORTH LIMITS

Photos along this shoreline segment.

The following photos further illustrate the gain of sand that has occurred Between 2010 and 2018 for the Northern Limits of the beach project.

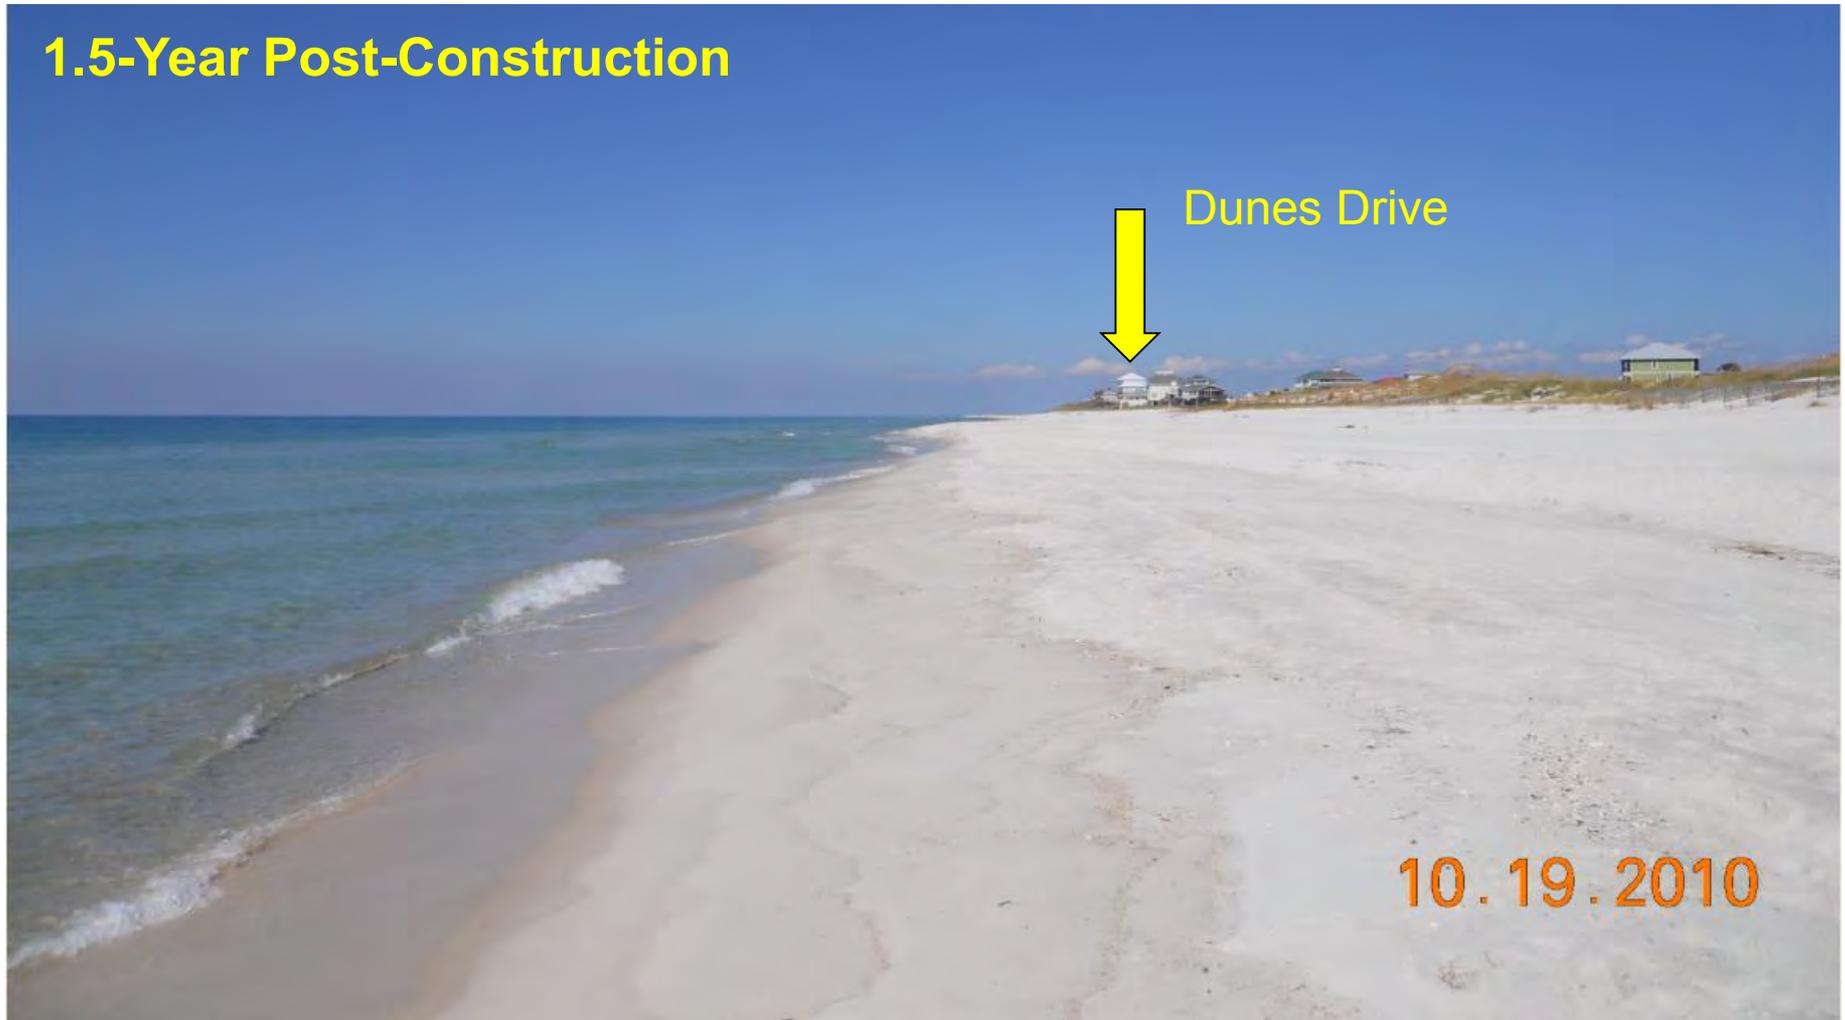
NORTH OF RISH PARK (1/4/18)

Beach is slightly wider than it was in 2010 and is higher in elevations than along the Southern Limits between Stumphole and Rish Park.

This beach segment is accreting (gaining) sand.

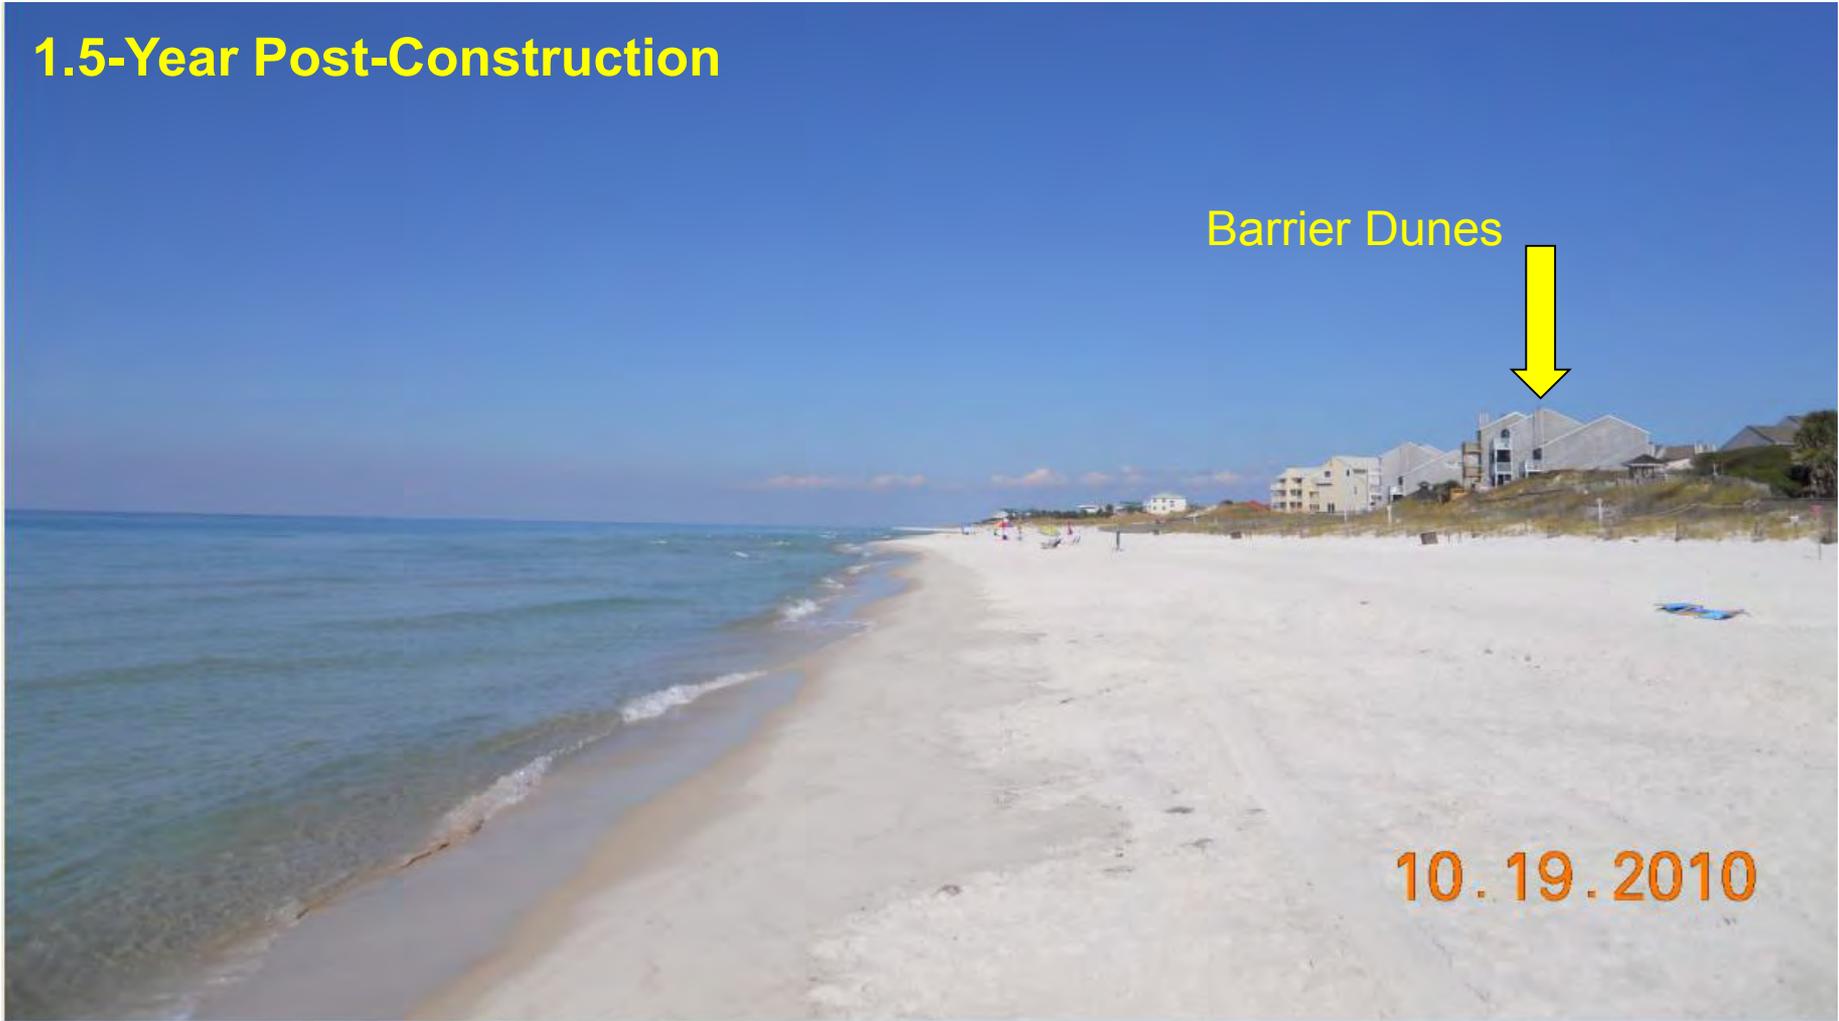
BARRIER DUNES (1/4/18)

Beach is slightly wider than it was in 2010 and is higher in elevations than along the Southern Limits between Stumphole and Rish Park.

This beach segment is accreting (gaining) sand.

Minor dune erosion north of Barrier Dunes along the Secluded Dunes Subdivision.

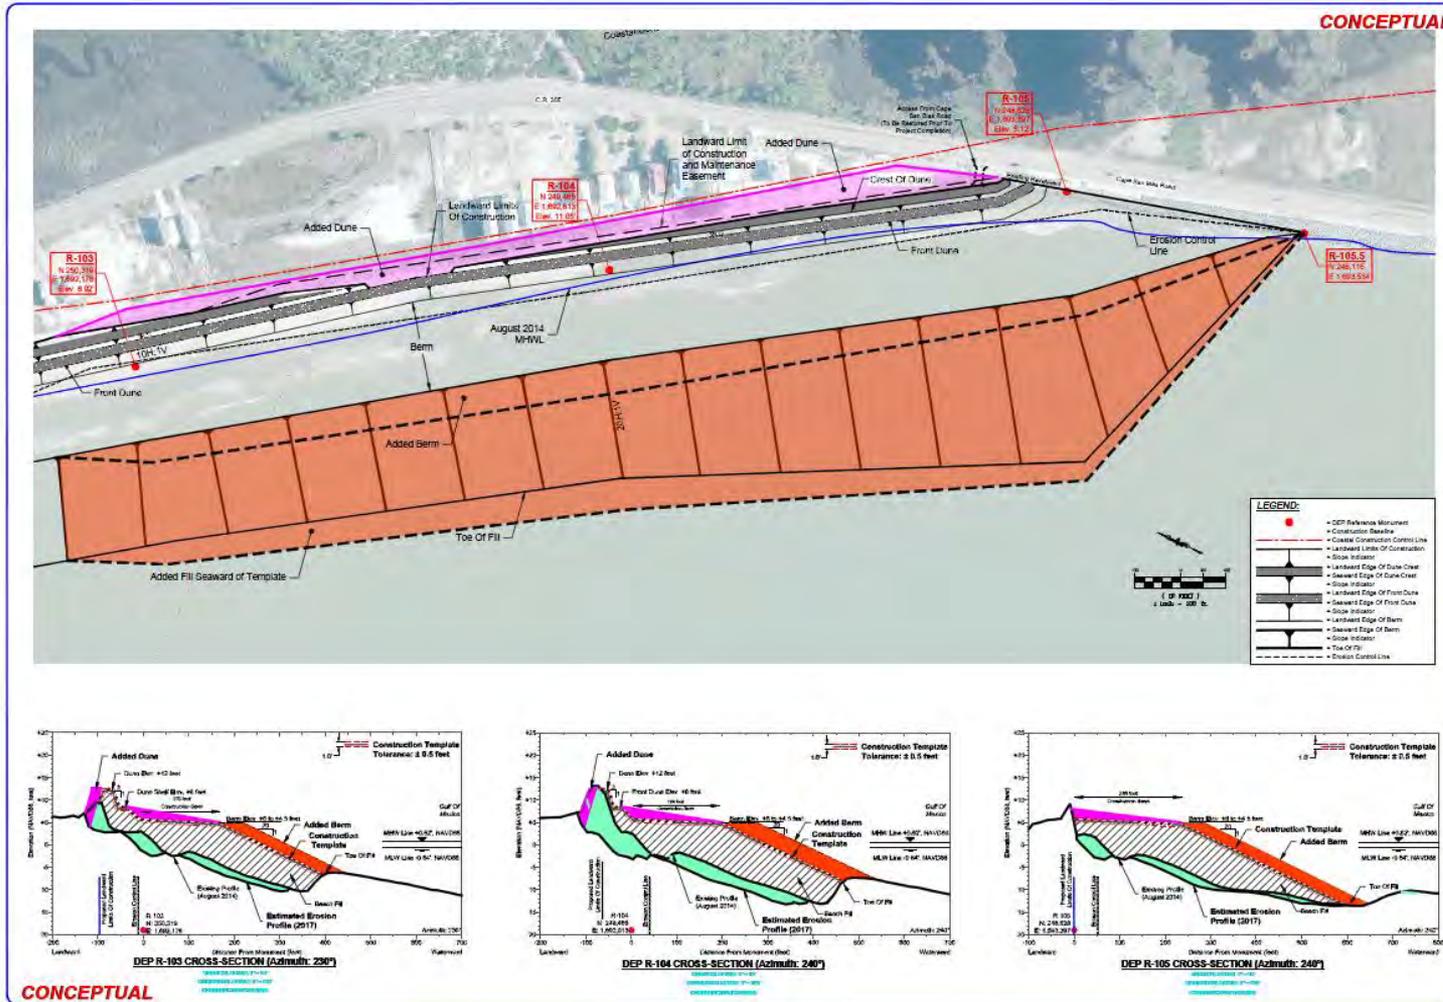
DEP MONUMENTS R-103 TO R-105 AND CROSS-SECTIONS
 St. Joseph Peninsula Beach Re-nourishment Project
 Gulf County Board of County Commissioners
 1000 Chad G. Cofer, Sr. Boulevard, P.O. Box 12046
 Panama City, Florida 32406

Fill limits and beach width will be required for bidders to estimate costs.
 More than one plan will be needed to estimate costs for varying volumes.
